### Software Program Change—Pool Sweep Boost Pump Operation

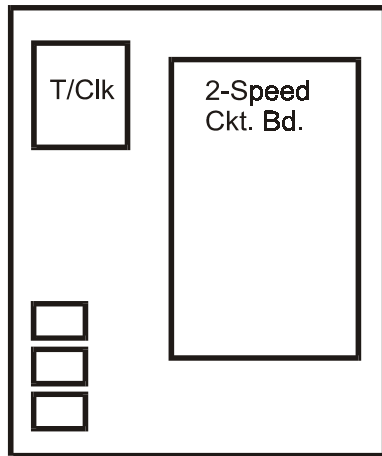
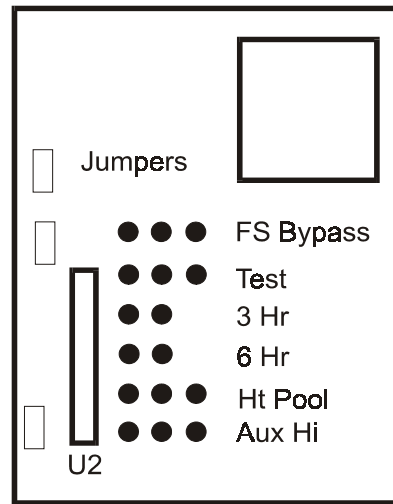
Motor Control Circuit Board and Front Panel

It has come to our attention that if the system is operating in the high speed mode in Automatic when the Spa button is activated the sweep boost pump is not turned off.

A software update was prepared and installed in systems produced after February 2004. The microprocessor IC located at U2 on the circuit board will be identified with "Pump 1.4" or later if this change has been installed.

- [ ] **Touch the bonding or ground connection in the enclosure.** (This will remove any static charge.)
- [ ] Very carefully slide a very small flat head screw driver between the CPU socket and the CPU IC (U2). The screw driver should enter from the bottom. Use the screw driver to slowly pry out the CPU IC from the socket. Do not bend any legs of the IC. Save the old IC.

- [ ] Locate the replacement "Pump 1.4" IC and with the notch at the top, insert the IC in the socket. Make sure the legs and the socket holes are aligned. Do not bend any of the legs. It may be easier if one side of the IC is inserted and then the other.
