Software Program Change—Pool Sweep Boost Pump Operation

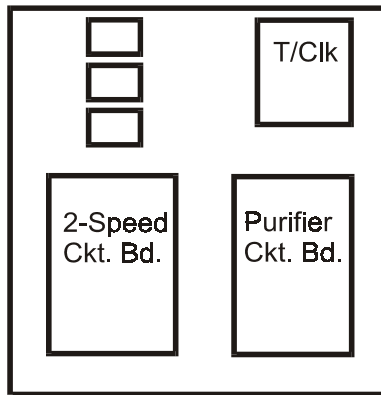
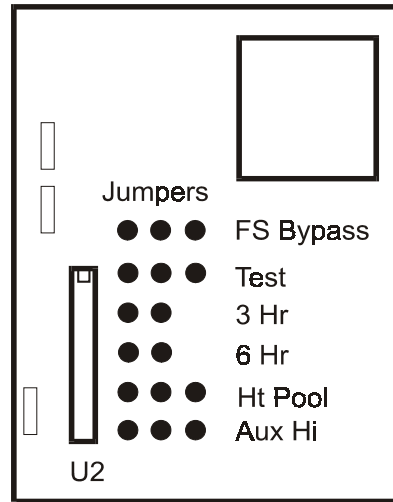
Motor Control Circuit Board and Front Panel

It has come to our attention that if the system is operating in the high speed mode in Automatic when the Spa button is activated the sweep boost pump is not turned off.

A software update was prepared and installed in systems produced after February 2004. The microprocessor IC located at U2 on the circuit board will be identified with “Pump 1.4” or later if this change has been installed.

- [] **Touch the bonding or ground connection in the enclosure.** (This will remove any static charge.)
- [] Locate the motor control board. Very carefully slide a very small flat head screw driver between the CPU socket and the CPU IC (U2). The screw driver should enter from the bottom. Use the screw driver to slowly pry out the CPU IC from the socket. Do not bend any legs of the IC. Save the old IC.

- [] Locate the replacement “Pump 1.4” IC and with the notch at the top, insert the IC in the socket. Make sure the legs and the socket holes are aligned. Do not bend any of the legs. It may be easier if one side of the IC is inserted and then the other.
